## I. Project description

1. **Project name:** Supporting live hood activities through agriculture in Meheba location integration area phase 2
2. **Project Implementation:** Association for Aid and Relief Japan (AAR Japan)
3. **Project location:** Meheba refugee camp in Zambia
4. **Project beneficiaries:** 54 refugees and local integrated peoples  
**Project duration:** from 5<sup>th</sup> April to 21<sup>st</sup> June (Training by Obed was up to 6<sup>th</sup> may. Construction continued without Obed Physically by 21<sup>st</sup> June, with daily online follow-up, led by Zambian Field assistant Gedeon).
5. **Project objectives:** Transferring labor-based skills of Do-nou technology to the refugees and local integrated peoples by rehabilitating the access road from main camp to the refugee's infrastructure and agriculture zone of Dambo-1, Dambo-2 and Kamiba
6. **Reported by** Eng. Ntakirutimana Obed

## II. Project summary outputs

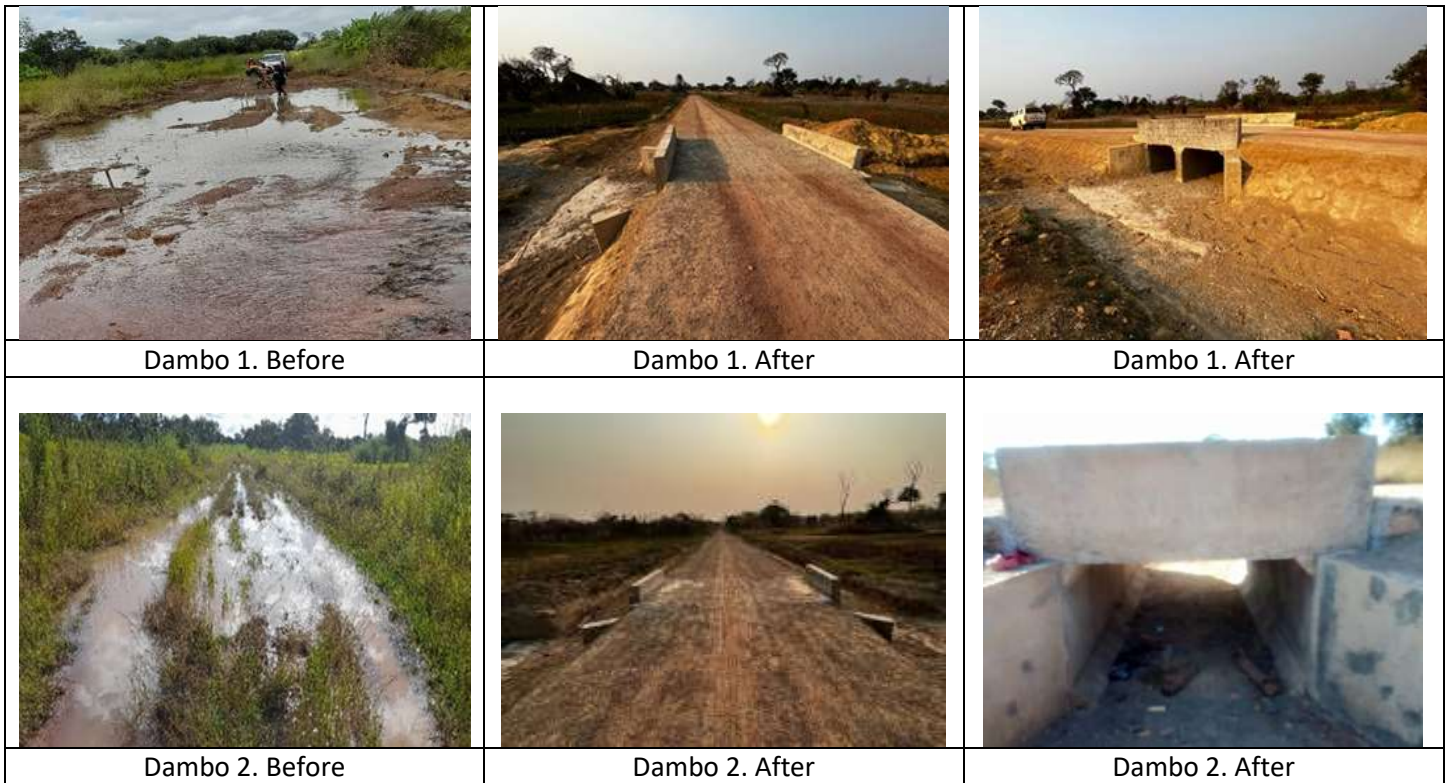
The two sections of the one road namely Dambo1 and Dambo2 are two separate sections of the road in wetland area of zone E in Meheba refugee camp with poor condition of flooding road by overland flow, the infiltration of water into the soil and not well maintained by ending result of a road is assumed to be completely closed when its crown is covered by water regardless of depth, The upper side of two sections are rice farms with a lot of water without irrigation to the agriculture zone and no bridges and water pass over the road profile to reach to the next down rice farms.

The proposed intervention was to raise up road profile and provide one single box culvert with one cross drain at each section of Dambo1 and Dambo 2 but by physical checking on field by receiving the past information from local peoples and observing the rain fall before 3days of starting project, the Proposed Intervention was changed by not using cross

drain rather than construction of double box culvert and raise up the road about 1m height at Dambo 1 and two separately single box culvert and raise up the road on 80cm height at Dambo2.

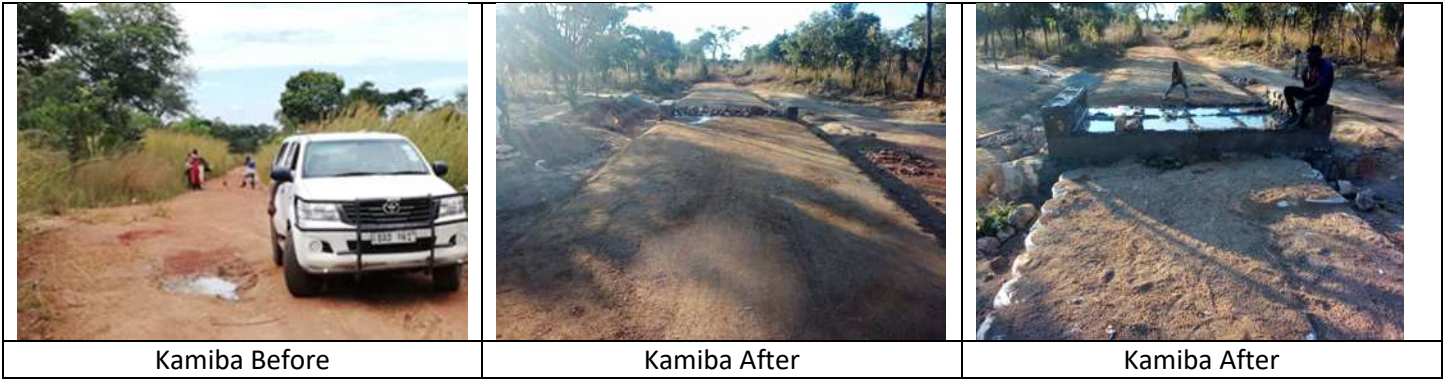
Kamiba zone is the section of the access road from main road to training center and primary school of Kamiba village, in middle of the road there is big pothole as result of water stagnation from rice farms in heavy rain without drainages on both side of the road and Road become impassable seasonally without maintenance.

The proposed intervention was to provide timber bridge at lowest point of the road similar as pothole to facilitate water from up side of the road to down side of the road after explaining all technical aspect on that timber bridge, the project implementer AAR Japan questioned about durability of timber because it is not possible to find good quality of timbers, they requested engineer to change the top slab materials by reinforced concrete cement rather than timber materials.

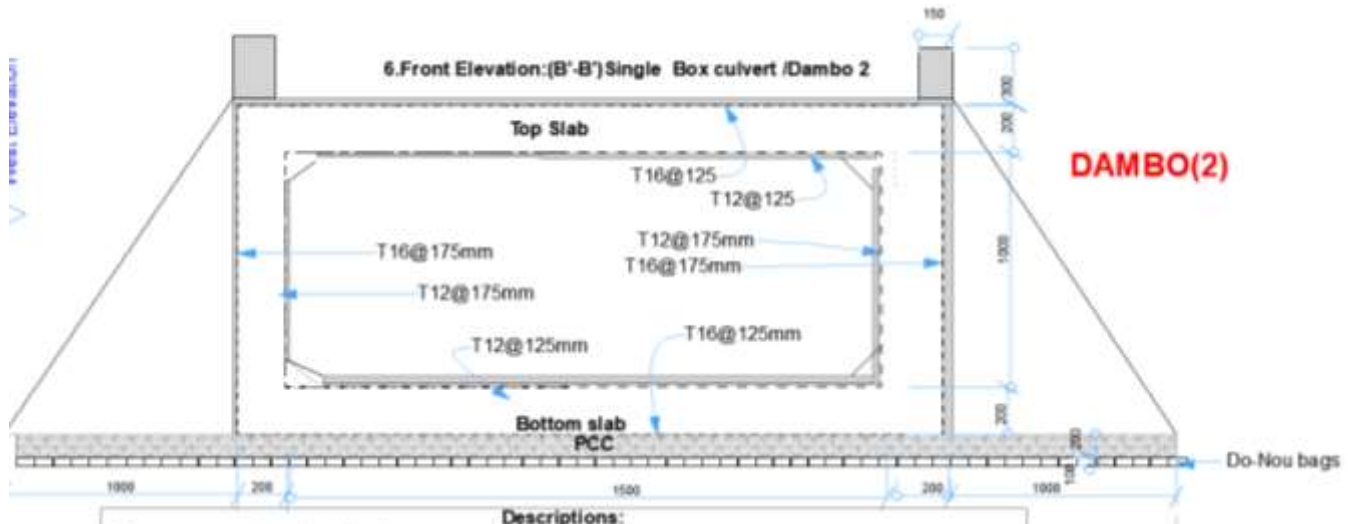
6 Front Elevation:(B'-B')Single Box culvert /Dambo 2

1. All measurement are in millimetre.
2. Size of box culvert is 3600x1900x1400
3. Concrete cover is 30
4. Main bars are  $\phi 12$  and  $\phi 16$
5. All Distribution bars are  $\phi 12$
6. Spacing is 125 c/c on Top and Bottom slabs .  
175c/c on walls and Distribution bars .
7. Concrete Grade : M20(1:1.5:3) For PCC  
M25(1:1:2) For RCC
8. One layer of Do-Nou bags has used in fondation for soft soil.
